DEPARTMENT OF TRANSPORTATION

Contract #: 04-0120F4Cty: SF/ALA Rte: 80 PM: 13.2/13.9File #: 69.28**WELDING INSPECTION REPORT****Resident Engineer:** Pursell, Gary**Address:** 333 Burma Road**City:** Oakland, CA 94607**Report No:** WIR-004370**Date Inspected:** 13-Oct-2008**Project Name:** SAS Superstructure**OSM Arrival Time:** 700**Prime Contractor:** American Bridge/Fluor Enterprises, a JV**OSM Departure Time:** 1730**Contractor:** Zhenhua Port Machinery Company, Ltd (ZPMC), Changxing Island **Location:** Shanghai, China**CWI Name:** Jeff Chan, CK Chen**CWI Present:** Yes No**Inspected CWI report:** Yes No N/A**Rod Oven in Use:** Yes No N/A**Electrode to specification:** Yes No N/A**Weld Procedures Followed:** Yes No N/A**Qualified Welders:** Yes No N/A**Verified Joint Fit-up:** Yes No N/A**Approved Drawings:** Yes No N/A**Approved WPS:** Yes No N/A**Delayed / Cancelled:** Yes No N/A**Bridge No:** 34-0006**Component:** Tower**Summary of Items Observed:**

WELDING INSPECTION REPORT

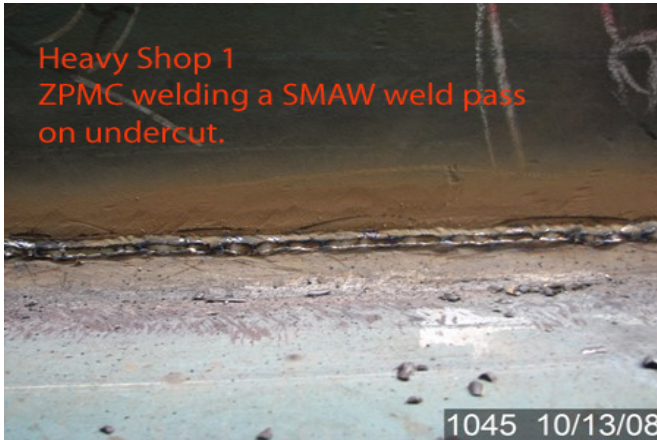
In process of repairing visual indication discovered by ZPMC and AB/F Quality Control Inspectors on longitudinal stiffener to skin plate C South Tower with the use of SMAW welding process. (Undercut and under fill).
